# Manhole Inspection Summary

Manhole # S43CC\_102MH

Record Plat: **43CC** Node: **102** Status: **New Manhole (Not in GIS)** Insp Date: **12/19/07 12:00 AM**

**Location** Address: **n.broadway st**

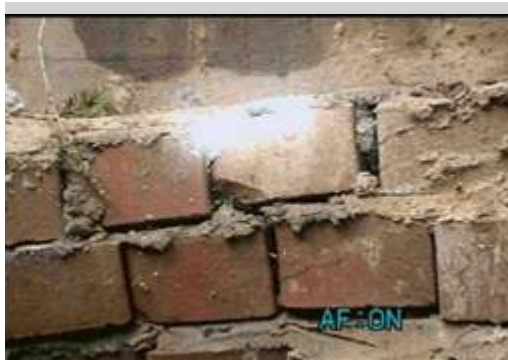
Defect 3

Condition: ☐ Sound ☐ Cracked ☐ Root Intrusion ☒ **Loose Brick** ☐ Deteriorated

chimney loose bricks

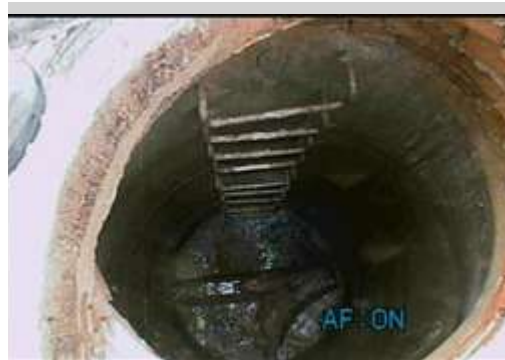
Defect 2

Count: **10** Missing: **0** ☒ **Corroded**

cor. steps

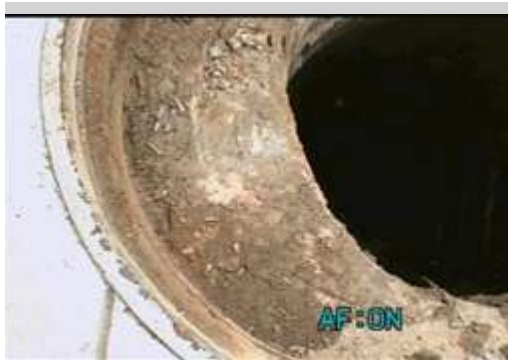
Defect 1

Offset: **7** (in.)

frame offset 7 inches

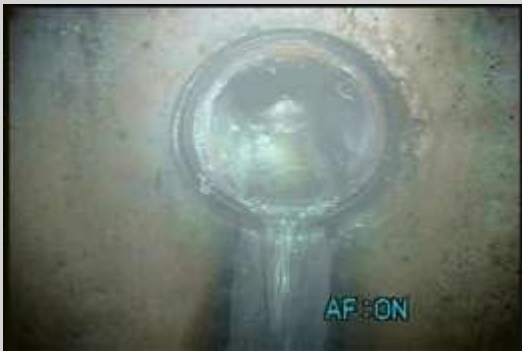
3 O'Clock Inflow

Drop In clogged with debris

Deposits: ☐ None ☐ Mud ☐ Sludge ☒ **Debris** ☐ Grease

Silt Depth: 1 (in.) Deposits Extent: **Light**

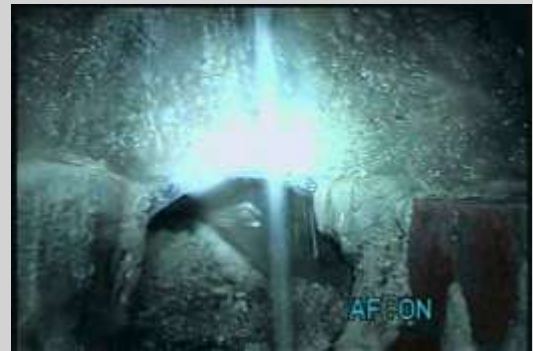
Drop In @ 3 O'Clock

Drop Condition: **Partly Clogged**
